Construction General Permit Compliance Evaluation Inspection Report

**Burma Road
Gotham Bay Road to Junction SH 97
Coeur d' Alene, Idaho**

**NPDES Permit Tracking Numbers:
IDR12C962, IDR12C968 and IDR12C974**

**Inspection date: March 25, 2014
Report completion date: May 21, 2014**

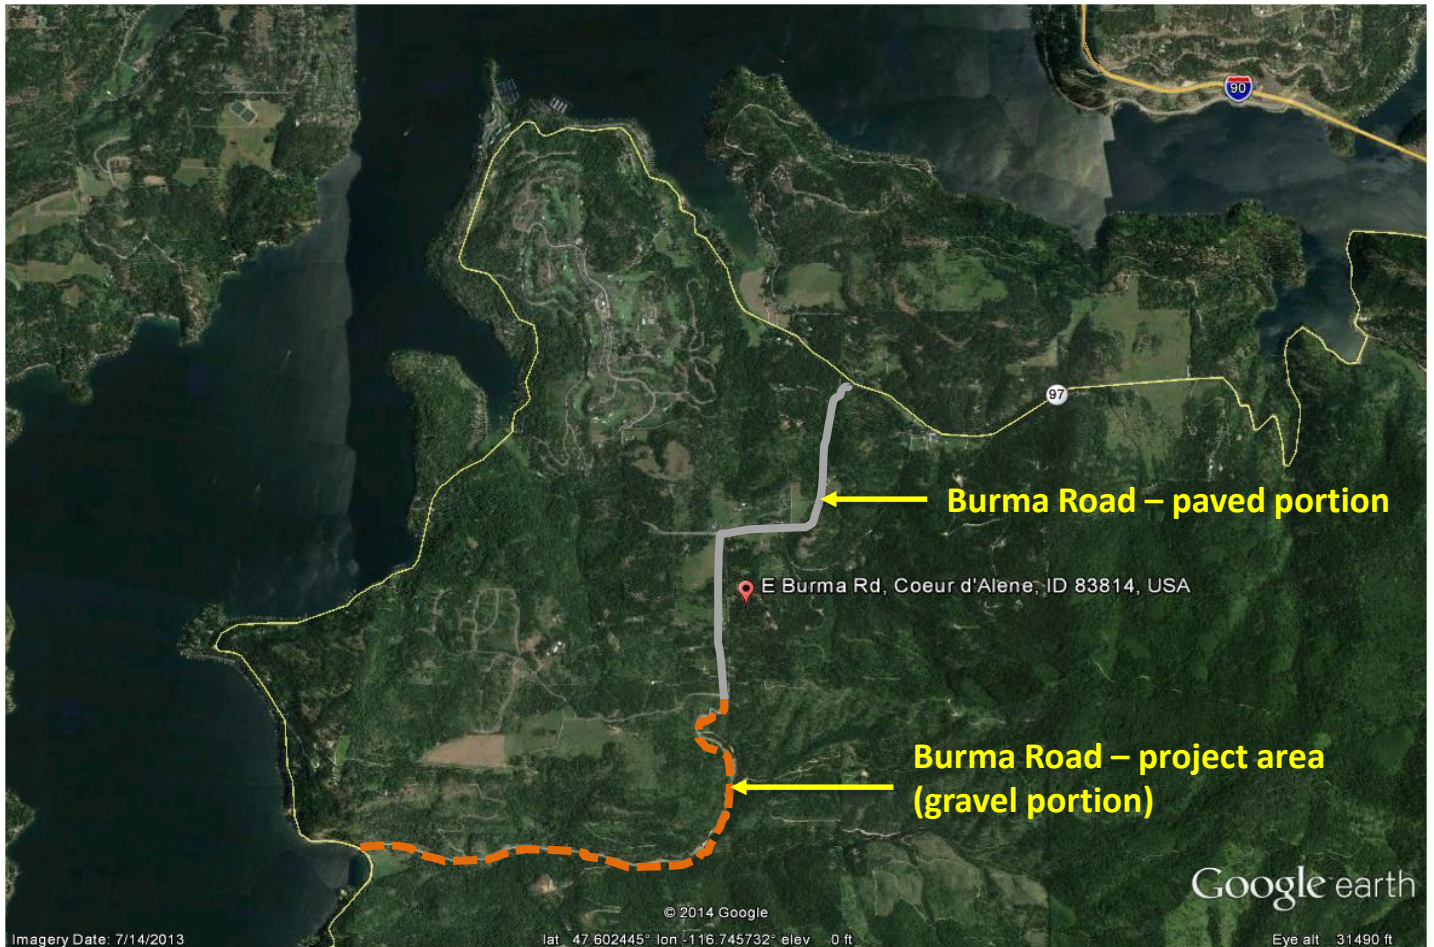
Photo No. 3 – from Google Earth Pro (imagery date 07/14/2013)
Burma Road details

State Highway (SH) 97 follows the irregular shoreline along the east side of Lake Coeur d' Alene from its intersection with Interstate 90 near the northeast end of the lake to its junction with SH 3 near the lake's southeastern end. Burma Road provides an alternate (i.e., shorter) cross-country route that bypasses a longer, irregular portion of the SH 97 shoreline route (see Photo 3).

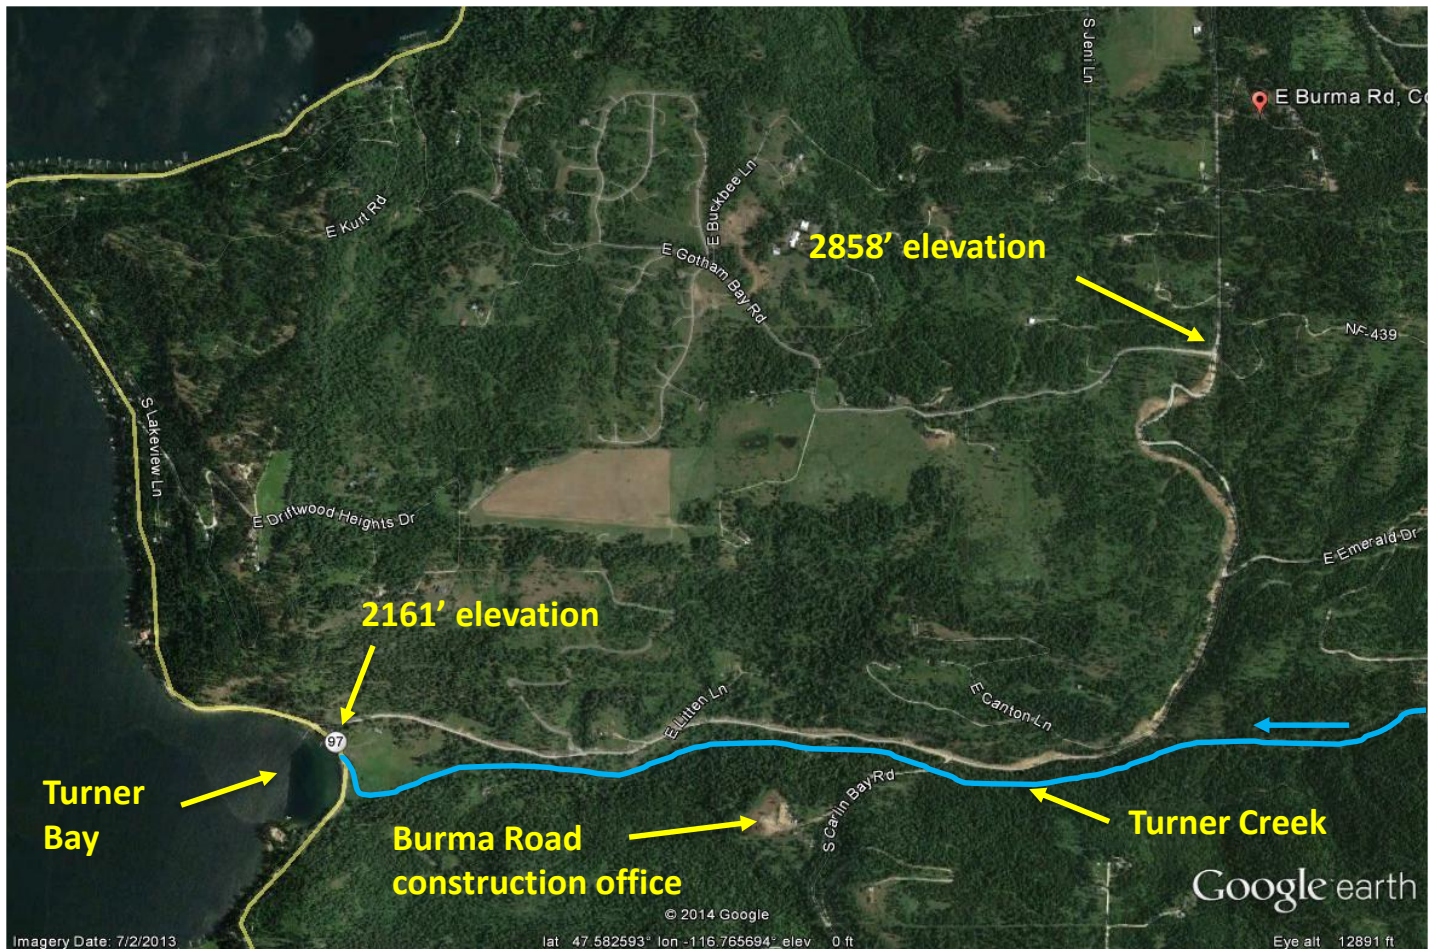
Photo No. 4 – from Google Earth Pro (imagery date 07/14/2013)
Burma Road and Turner Creek

Burma Road is approximately five miles in length. Though the road is heavily traveled, less than half is paved. The remaining portion (approximately 2.8 miles from the junction with Gotham Bay Road to SH 97) is gravel. The gravel portion is narrow, winding, and parallels Turner Creek for much of its length (see Photo 4). The primary focus of the Burma Road project is to widen and pave the gravel section. Throughout its entire length, the project involves a number of road cuts into steep hillsides.

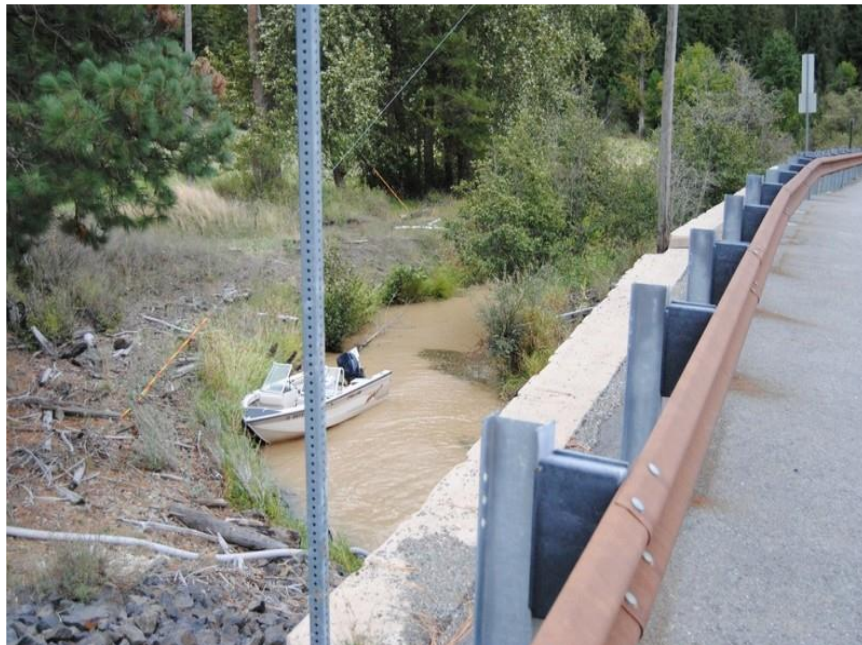
Photo No. 8 - Photo and description from report by Karissa Hardy, Rain Event 9/28/2013 – 9/30/2013
“Turner Creek at mouth of Lake Coeur d’ Alene”

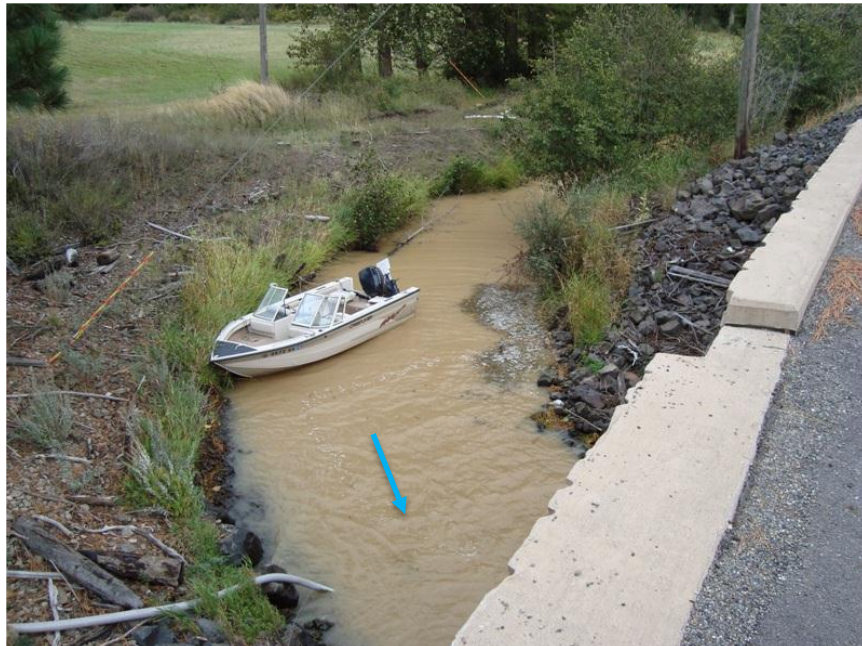
Photo No. 8a – Photo by June Bergquist; 9/30/2013
Turner Creek at SH 97 bridge

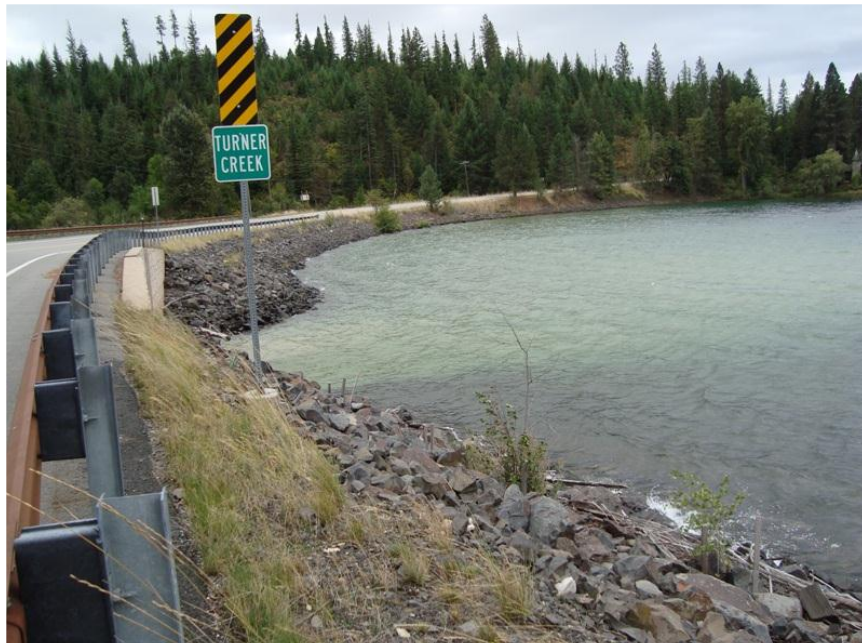
Photo No. 8b – Photo by June Bergquist; 9/30/2013
Turner Creek discharge into Turner Bay/Lake Coeur d' Alene

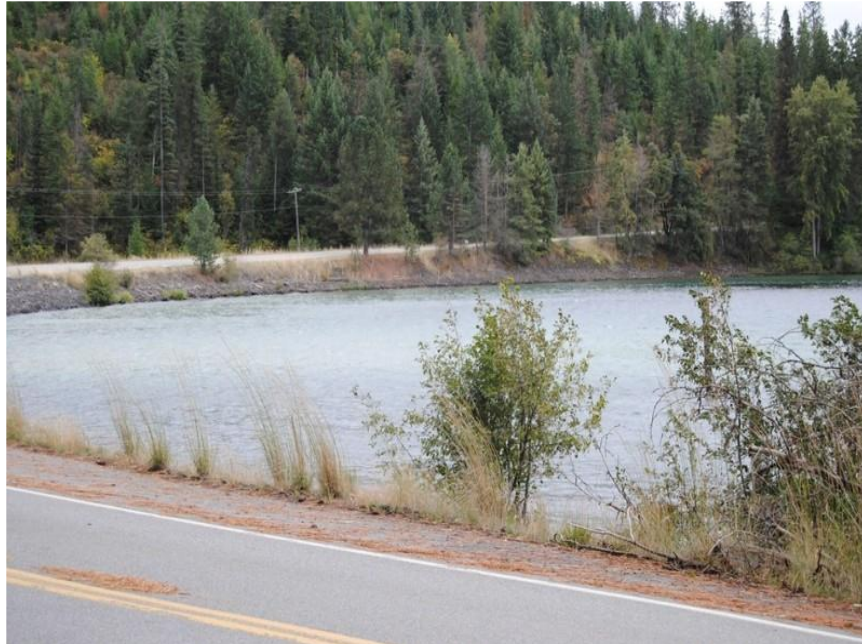
Photo No. 9 - Photo and description from report by Karissa Hardy, Rain Event 9/28/2013 – 9/30/2013
“Turner Bay at Lake Coeur d’ Alene”

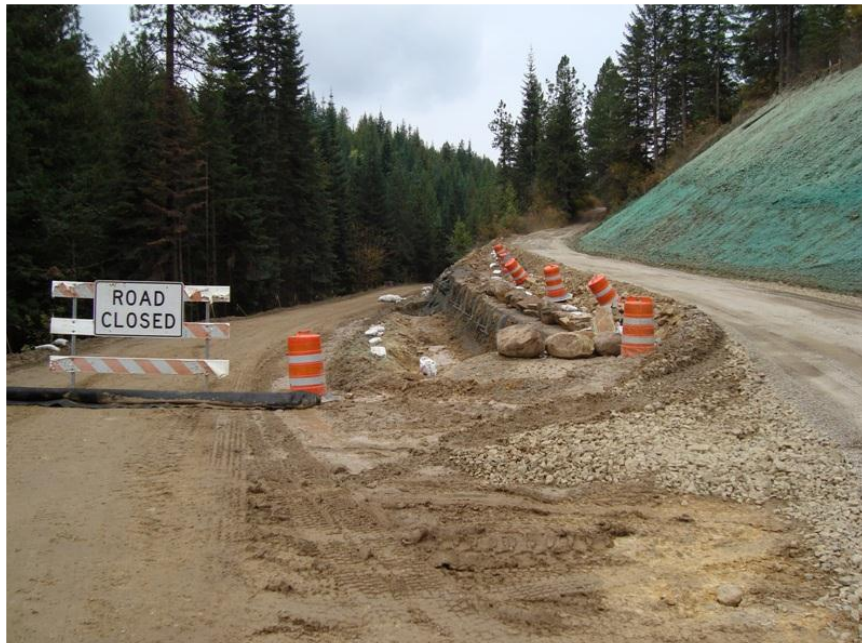
Photo No. 14, Photo by June Bergquist; 10/10/2013
Soil nail wall and BFM coated slope at Canton Lane

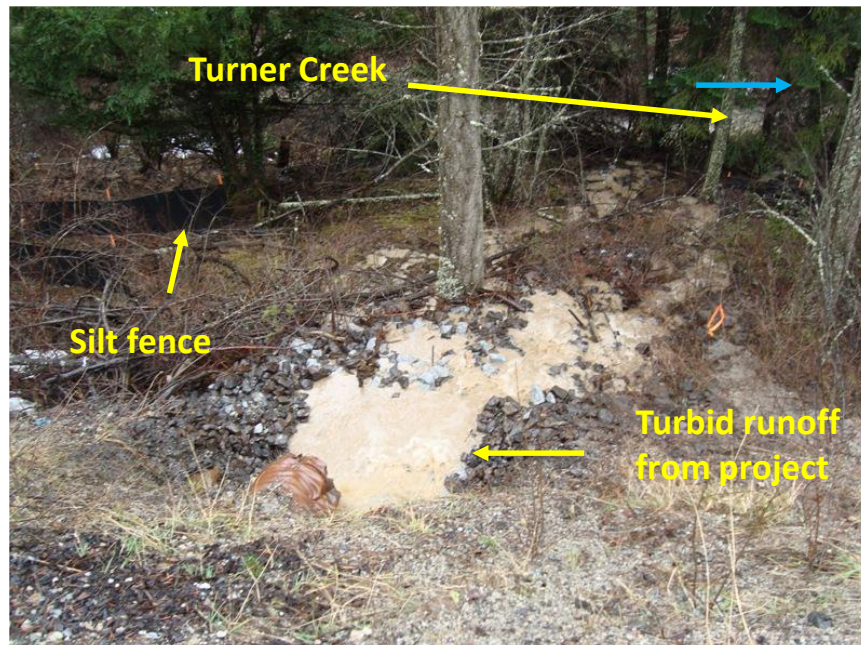
Photo No. 24, Photo by June Bergquist; 03/14/2014

Turbid stormwater runoff from project flowing to vegetative area above Turner Creek

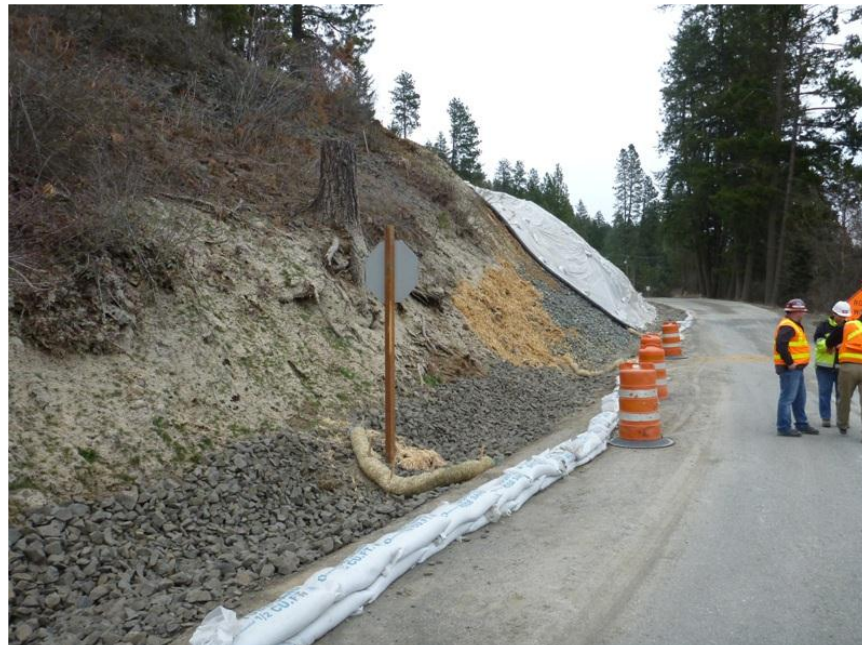
Photo No. 26 (P1000412)

Facing east – the beginning of the Burma Road project.

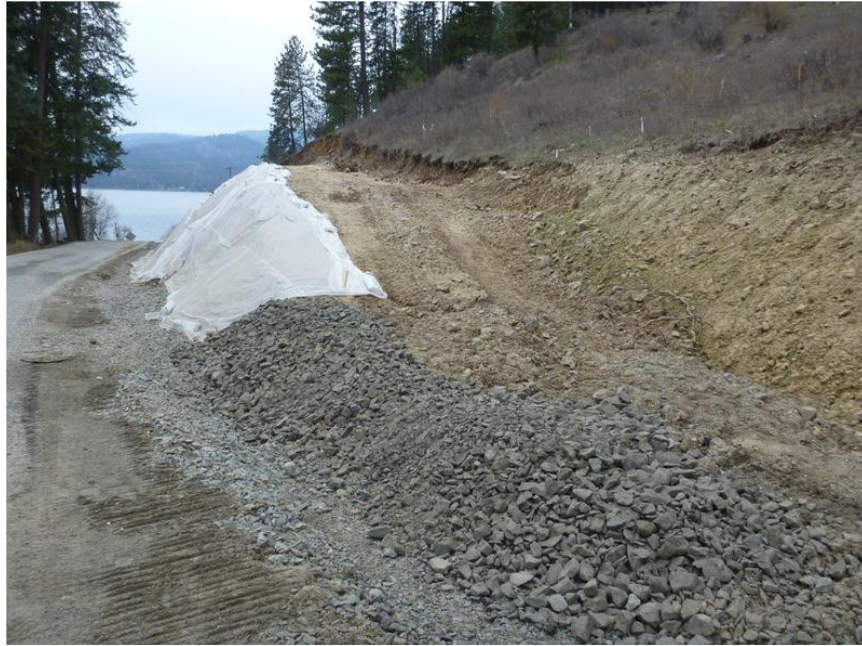
Photo No. 29 (P1000415)

Facing west – the road junction and start of project (Photos 26-26) lies just below the crest of the road;
Lake Coeur d' Alene is visible in the background.

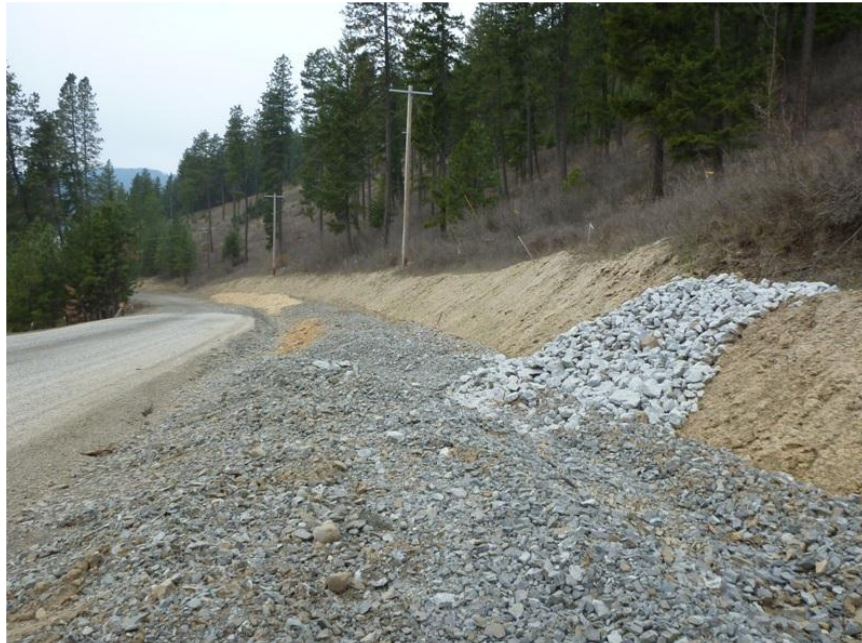
Photo No. 30 (P1000417)

Facing west – a short distance from the start of the project, the BFM is holding on some of the shallower slopes; the rock armor fills in a location where saturated soil was removed from a significant seep.

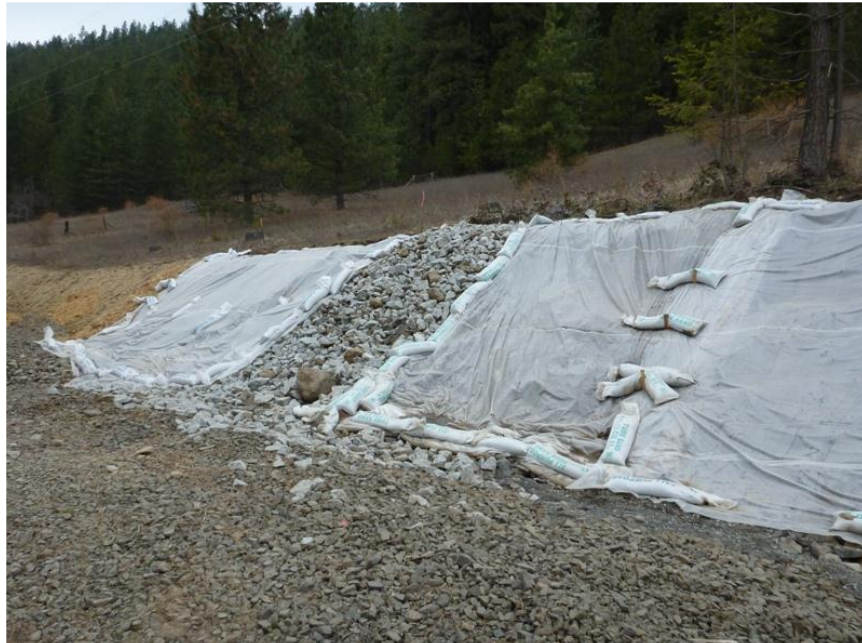
Photo No. 32 (P1000421)

Facing northwest – the rock armor was installed to replace saturated soil in area of a significant seep; the visqueen was applied later after failure of the BFM.

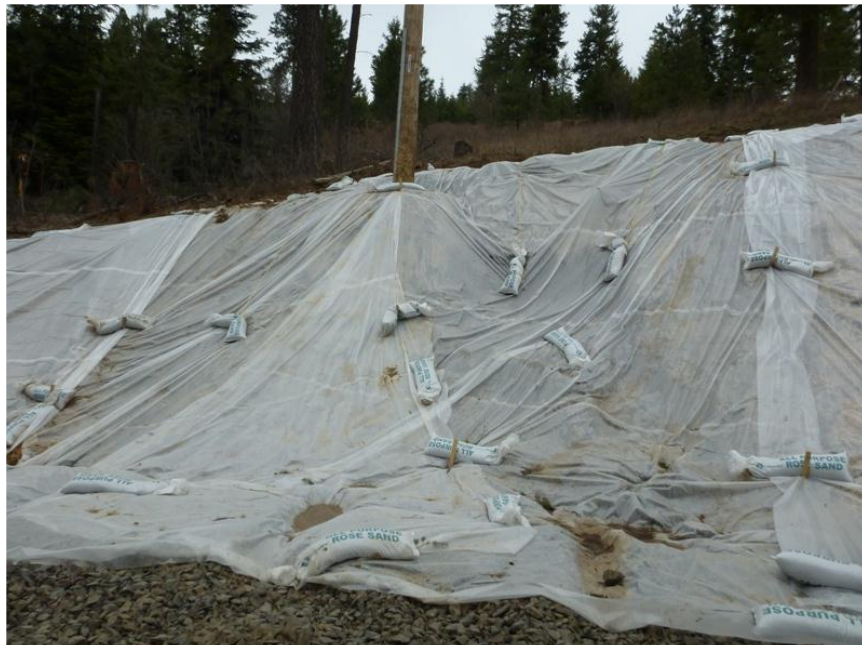
Photo No. 34 (P1000423)

Facing northwest – erosion and slope failure threatens the integrity of this utility pole.

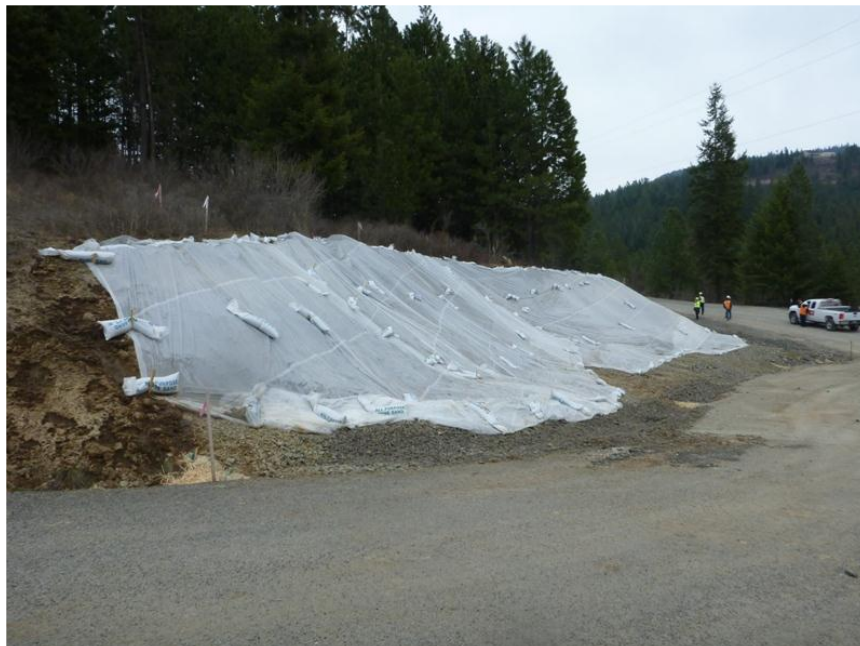
Photo No. 36 (P000426)

Facing southeast – this slope is at the base or entrance to Skyview Lane; the first of three private roads leading into Burma Road from the north.

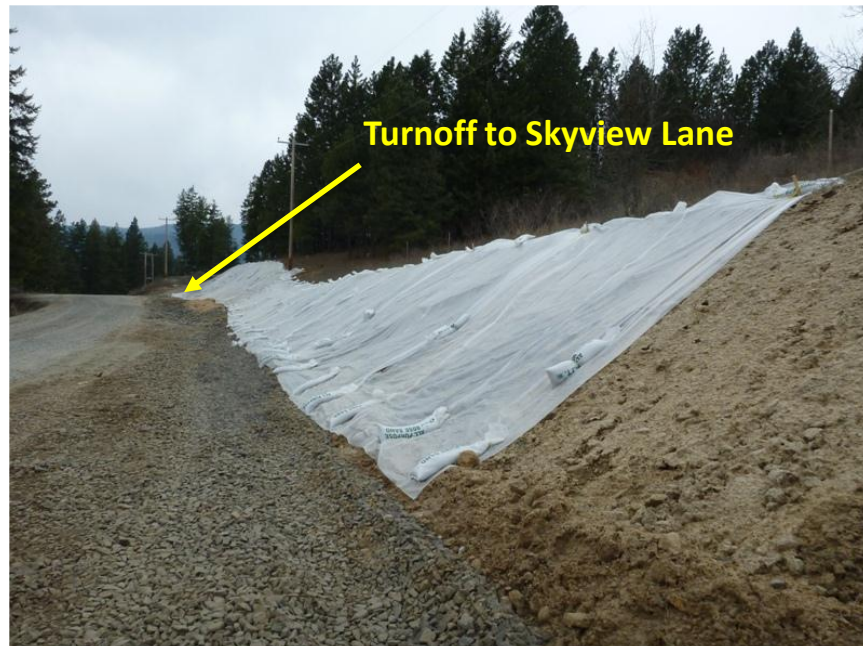
Photo No. 37 (P1000429)

Facing west – this is the far end of the slope noted in the previous photo.

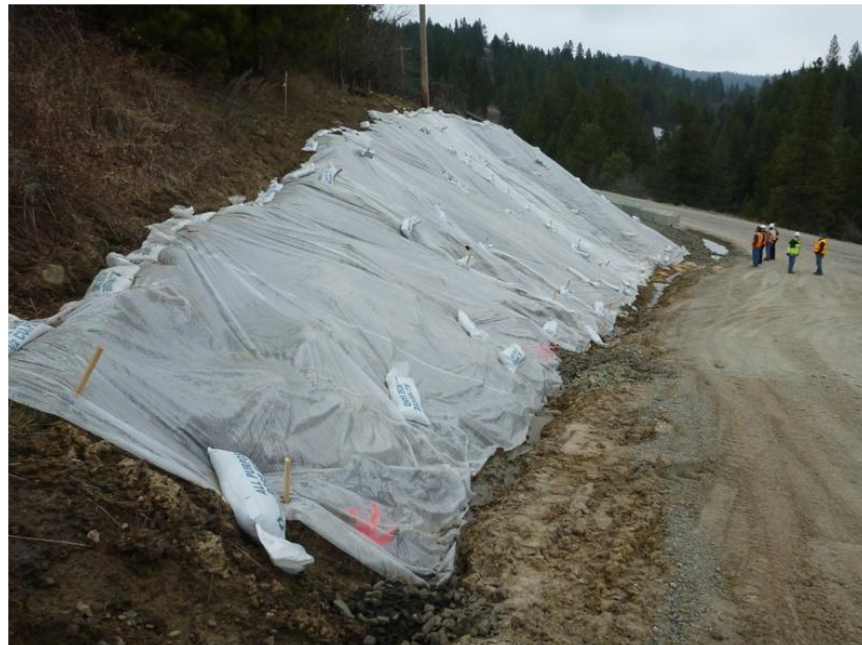
Photo No. 38 (P1000430)

Facing southeast – traveling east on Burma Road, this slope is on the approach to the second private road - E. Litten Lane. This area has experienced some of the worst of the slope failures.

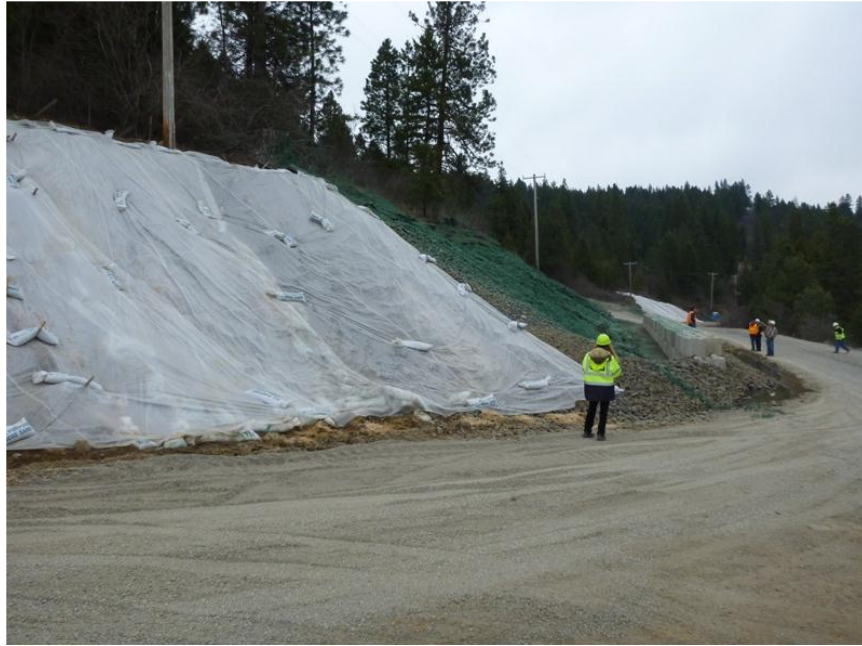
Photo No. 39 (P1000431)

One of the most problematic areas observed during the site tour (conducted primarily on foot starting from the west end of the project at the intersection with SH 97) involved the steep cut slope along the entrance to E Litten Lane. According to the stormwater inspection reports, this slope has exhibited extensive slope failure since January, 2014 at the latest. Project engineers claim that the slope is currently too unstable to safely implement a long-term solution (there may also be an easement issues since so much of the slope has sloughed off ; any long-term fix will likely require the removal of soil to reduce the angle of the slope which will, in turn, require the acquisition of property rights beyond the existing slope). As a temporary measure, "eco-blocks" (large concrete barriers made from left-over or unused concrete) have been placed along the toe of the slope to keep soil from inundating E. Litten Lane. The slope face was hydroseeded the very day of this inspection; the E. Litten Lane slope was bare when I passed it on the way to the construction site office in the morning but it was coated with the green hyroseed material by mid-afternoon. Portions of the slope had already begun to show signs of slope failure by the time the tour began (see Photos 41 and 44). A major slope failure at E. Litten Lane could result in the discharge of significant amounts of sediment to Turner Creek.

Facing east – approaching E. Litten Lane and the worst of the slope failures.

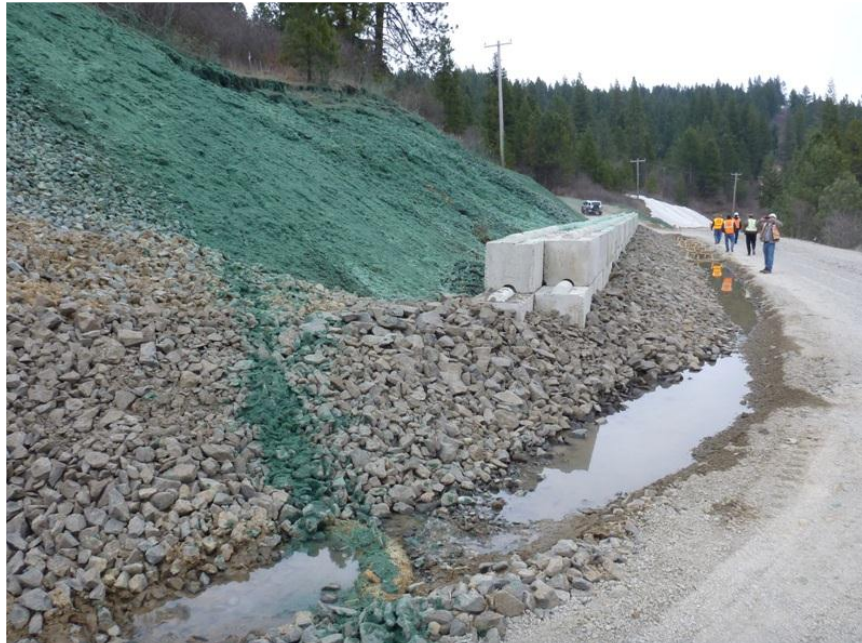
Photo No. 40 (P1000432)

Facing east – Burma Road drops and curves to the right, E. Litten Lane curves to the left. The green area was hydroseeded between the time I first arrived at the site and the time of the site tour.

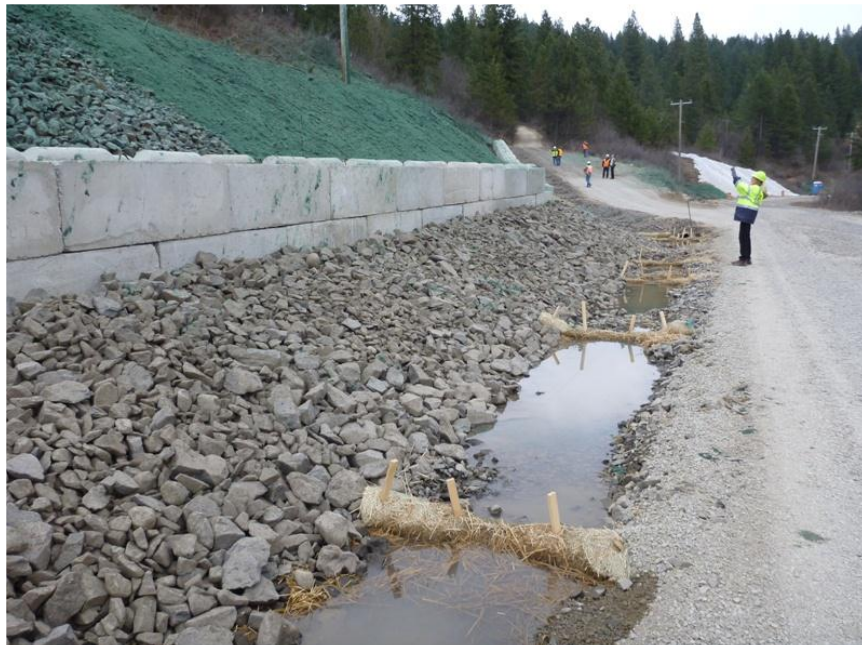
Photo No. 42 (P1000435)

Facing east – the concrete “ecology” blocks have been placed all along the toe of the slopes along the E. Litten Lane area in an effort to hold back the unstable soils.

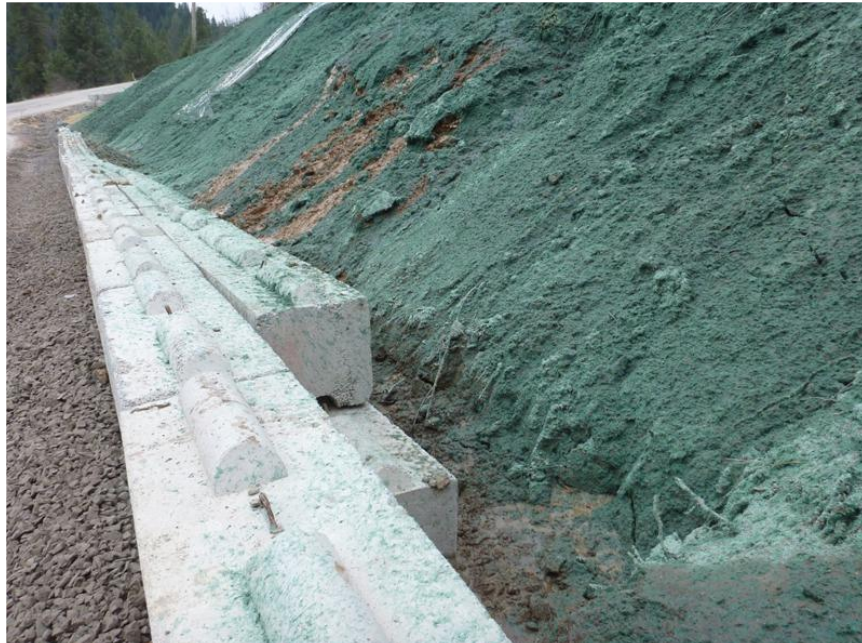
Photo No. 44 (P1000439)

Facing southwest – this is the far end of the E. Litten Lane slope. The operators claim that the slope must dry out before it is safe to repair it. Since the top of the slope has eroded back to the border of the current easement, property purchase may be necessary before final repairs can be made.

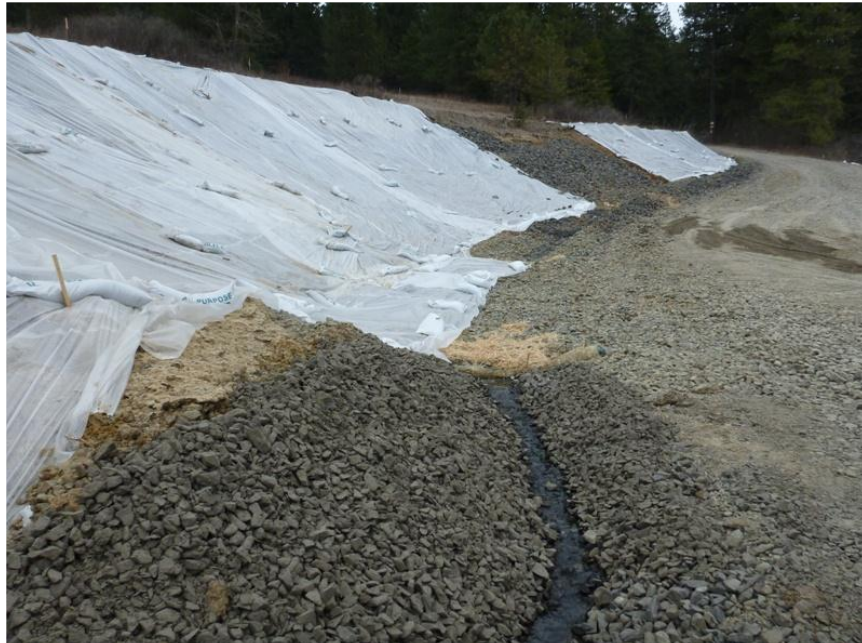
Photo No. 46 (P1000444)

Facing east – the eroded slopes along Burma Road east of the junction with E. Litten Lane.

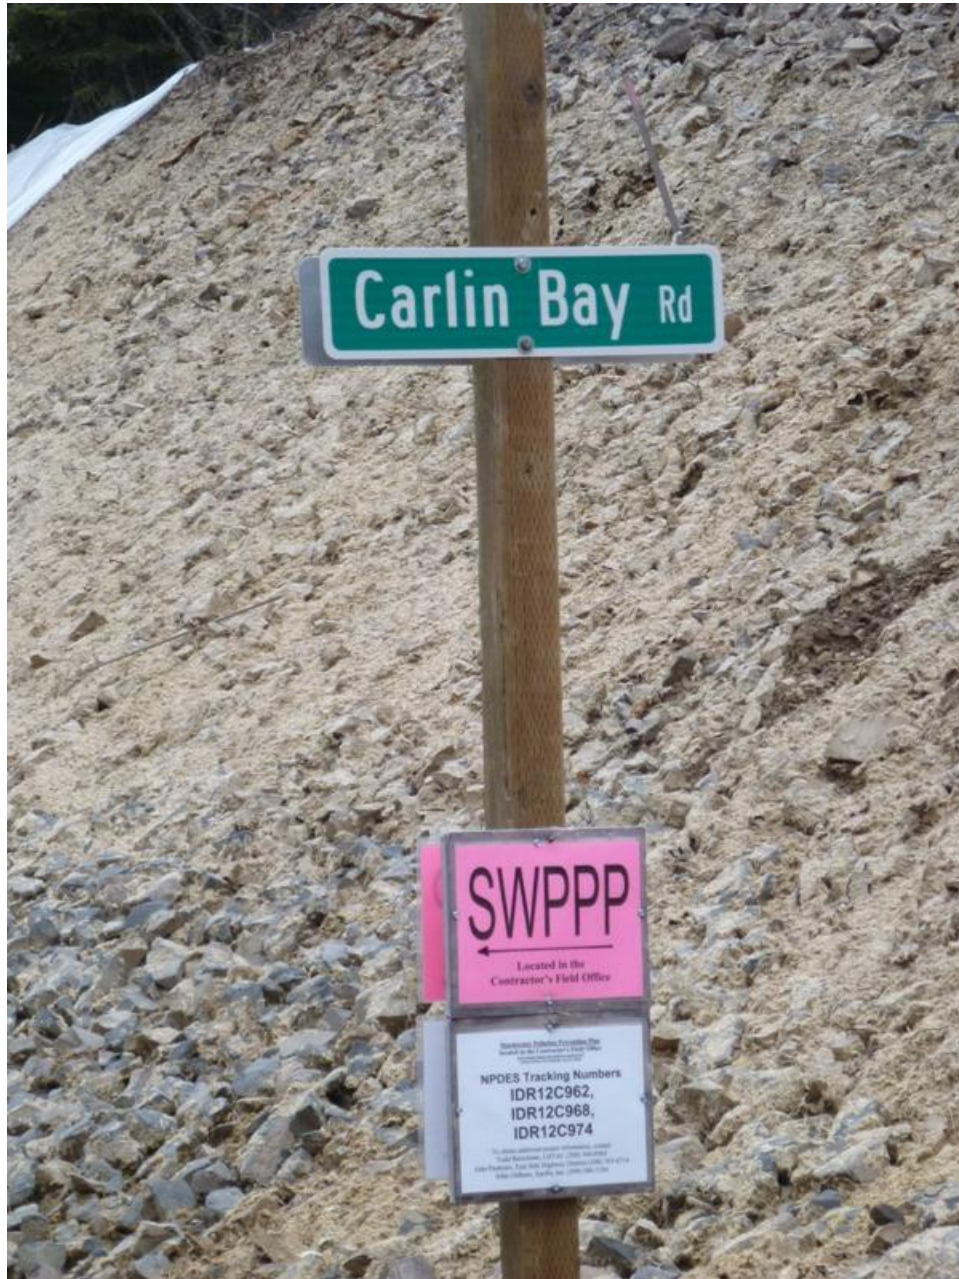
Photo No. 49 (P000450)
Facing west northwest – the SWPPP notice posted on the north side of Burma Road
across from the junction with Carlin Bay Road noted in the previous photo.

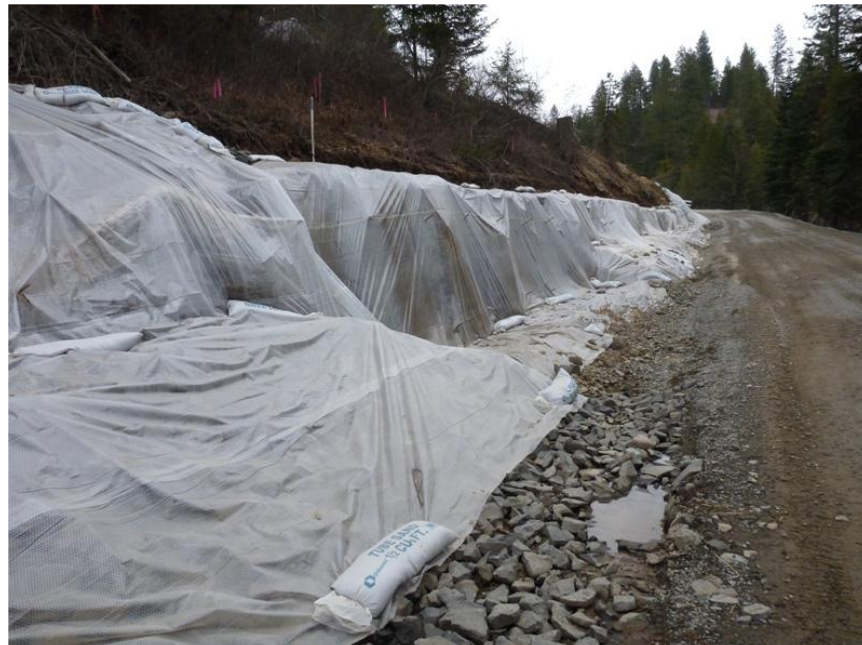
Photo No. 51 (P1000452)

Facing northeast – the soil nail wall is shrouded in visqueen near the upper portion of the Burma Road project.
